# Manhole Inspection Summary

Manhole # S35II\_058MH

Insp Date: **3/14/07 8:46 AM**

**Location** Address: **326 FEDERAL ST**

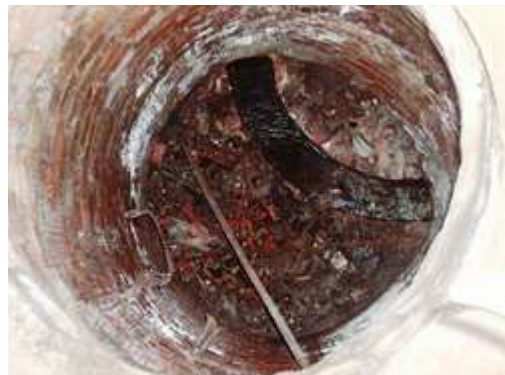
Top View

Missing and corroded steps. Evidence of surcharge - Bench debris. Channel debris.

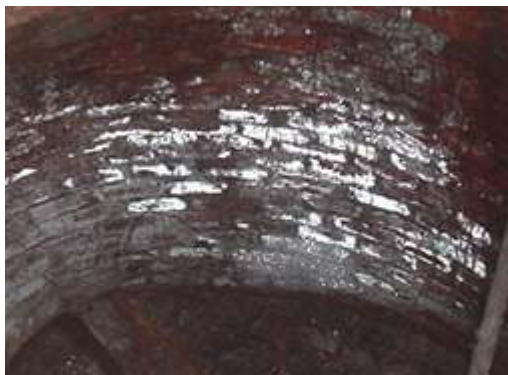
Defect

Barrel infiltration.

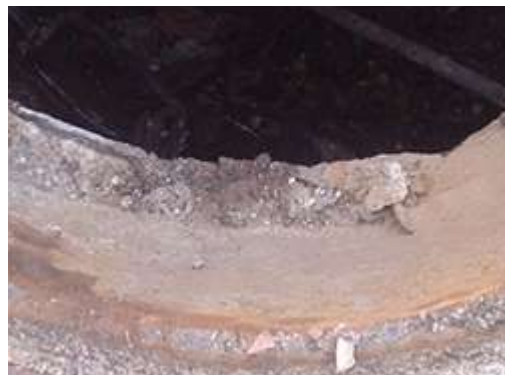
Defect

Frame offset. Adjustment deterioration and infiltration.

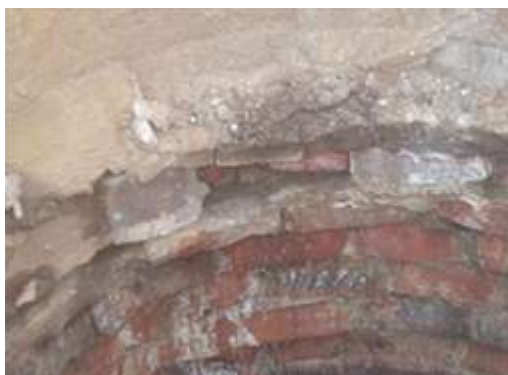
Defect

Adjustment deterioration and infiltration.

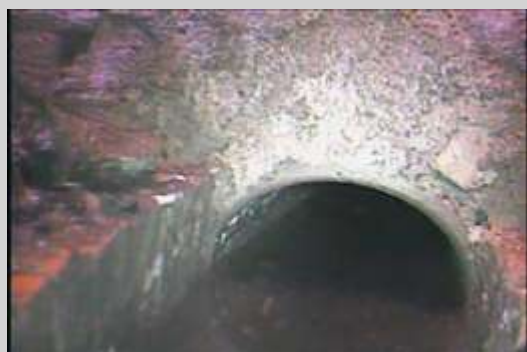
Pipe In @ 9 O'Clock

Deposits: ☐ None ☒ **Mud** ☐ Sludge ☒ **Debris** ☐ Grease

Silt Depth: **1** (in.) Deposits Extent: **Light**
